January 9, 2009

Garner, NC 27529

REPORT SUMMARY

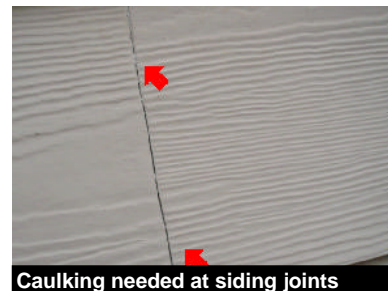
Front Elevation: Building paper, metal lath, and plywood exposed at stone wall front elevation.

Areas exposed at vertical trim boards, above foundation vents, around window, and right of window at wall. Standard building practices for the application of stone are to cover the area behind the stone with a cementitious coating to prevent areas where wind driven rain entry could occur. Building paper, exposed lath, or wall sheathing should not be exposed. Recommend consulting with licensed general contractor regarding exposed areas and what corrective measures are needed. Recommend painting under side of trim at porch post to prevent water wicking up into trim which could cause rotting. Caulking/ sealing needed at siding adjacent to porch surface to prevent water entry (see photo).

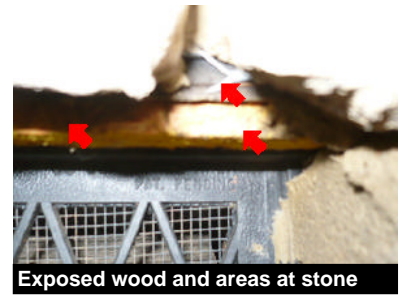
Exposed wood and areas at stone

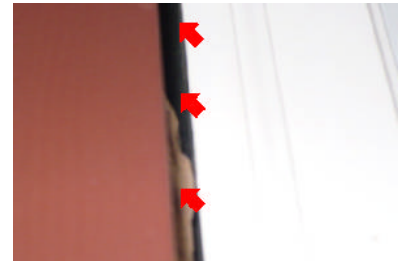
Exposed areas at window and stone

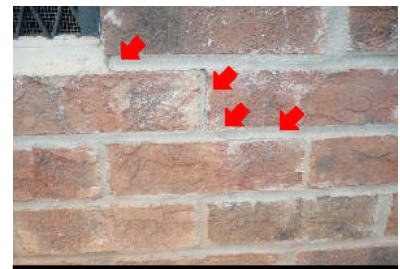
Left Elevation: Hair line crack in foundation wall by front foundation vent. Evidence indicates some settling. Recommend sealing crack to prevent water entry which could freeze, expand, and cause crack to enlarge. Recommend consulting with licensed general contractor regarding crack and what corrective measures are needed.

Hair line crack at foundation wall

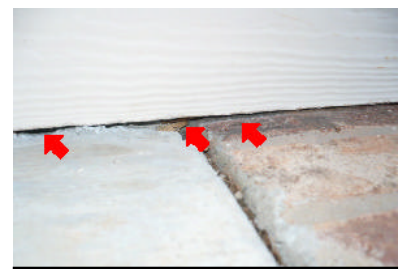
Caulking needed at siding and porch

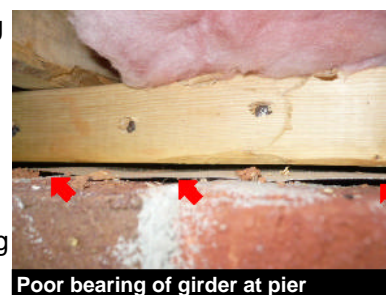
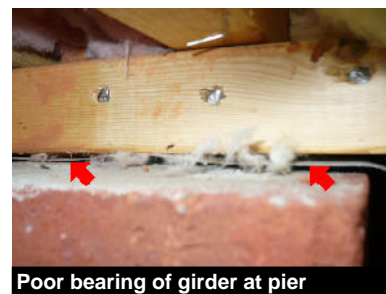
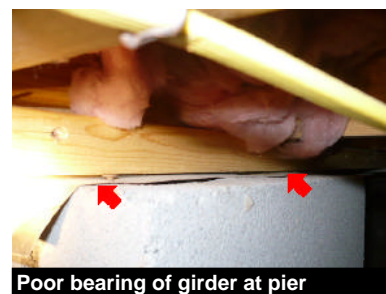
BEAMS: Wood, Poor end bearing is found: poor bearing of girders on three piers observed. Poor bearing at two piers by crawl space door and poor bearing near front porch area. Girder spans over pier without bearing. See photos. Plumbing pipes in area are passing over the top of girder. Recommend investigating girder further for areas cut or notched where plumbing pipes pass directly over top. Recommend consulting with licensed general contractor regarding lack of bearing on column and what corrective measures are needed.

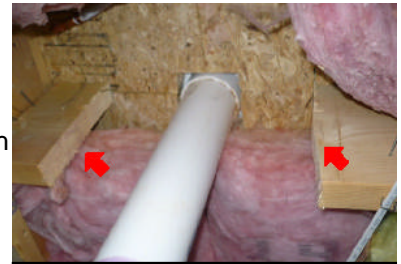
Wood, Floor joist is cut around plumbing pipe under powder bathroom. See photo. Floor joist is not support by hanger at rear of crawl space right side of deck as facing rear of home (see photo for location). Recommend consulting with licensed general contractor regarding cut floor joist and lack of support at hanger and what corrective measures are needed.

Floor joist cut around plumbing pipe

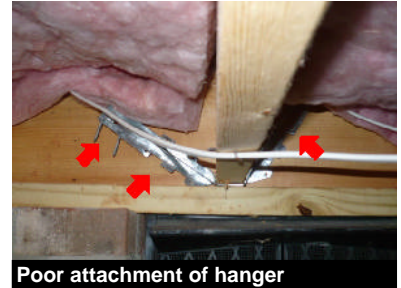
Poor attachment of hanger

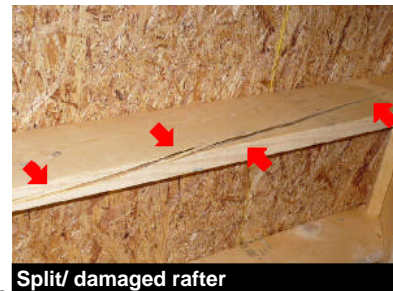
Split/ damaged rafter

Split rafter noted by air handler and hot water heater. Split travels through rafter. A split/ damaged rafter can reduce the load capabilities of the rafter. Recommend consulting with licensed general contractor regarding damaged rafter and what corrective measures are needed.

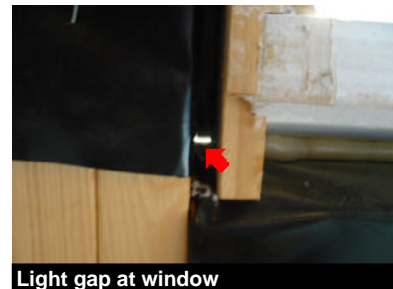
Light gap at window

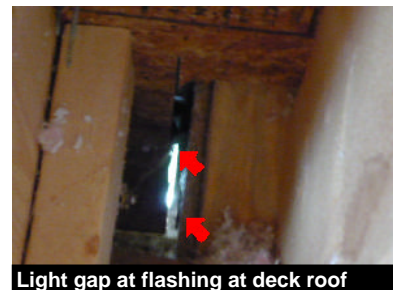
Light gap at flashing at deck roof

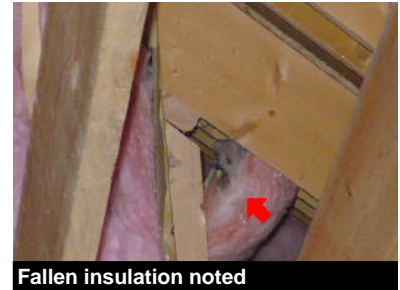
Attic, Fiberglass- Blown, Fiberglass batts, Fallen insulation noted: at knee wall by bonus dormers. Repair as needed. Crawl, Batts, Functioning as intended.

Fallen insulation noted

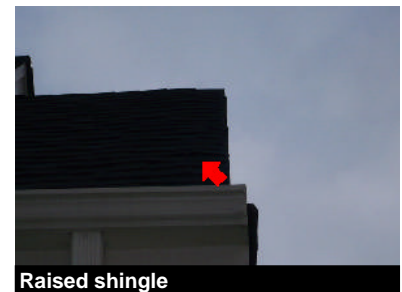
Raised shingle

Raised Shingles observed: Front elevation: raised shingle at front left gable- see photo. Rear Elevation: raised shingle noted left of covered porch - see photo for location. Recommend roofing contractor secure all raised shingles in order to prevent wind driven rain from entering and possibly damaging roof decking or leaking inside the home. Torn shingles noted: gable edge at dining room. A licensed roofing contractor should be called to make further evaluation and repairs as needed.

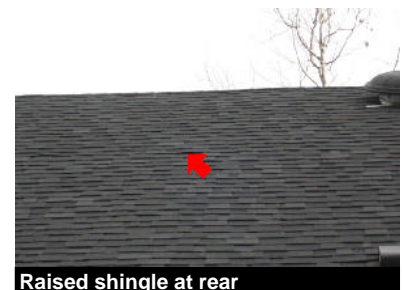
Raised shingle at rear

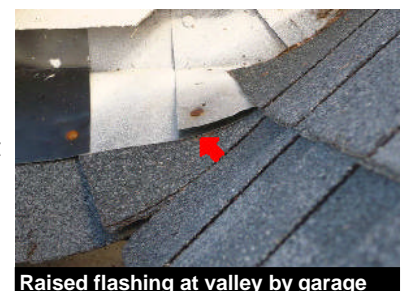
Metal, The potential for water entry is present: raised flashing at valley at garage and dining room. Void at flashing at left water table at dining room gable, exposed wood observed-see photo. Improperly installed flashing at right dormer against fascia and roof at garage. Flashing is installed on exterior of wood rather than behind framing. Potential for water entry behind flashing. Raised flashing at bath vent fan hood at right elevation. Secure as needed to prevent water entry. Loose/ raised flashing at right side of covered deck against side of house. Potential for wind driven rain entry. A licensed roofing contractor should be called to make further evaluation and repairs as needed.

Raised flashing at valley by garage

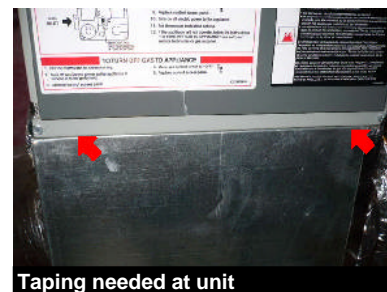
SECONDARY UNIT: Attic: Comprehensive evaluation of the heat exchanger and combustion compartment are excluded from this inspection due to visibility and design limitations of the furnace. If you have concerns - recommend having licensed HVAC dealer conduct specialized testing in order to give comprehensive evaluation. Air leaks around return side of unit. Unfiltered air observed being pulled into unit at return. Taping needed at unit. Have licensed HVAC mechanical contractor evaluate the heating system.

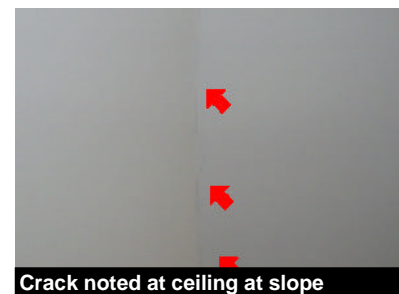
CONDITION: Drywall, cracks noted in ceiling second floor at ceiling slope and by dormer. Gaps noted around crown molding and ceiling.

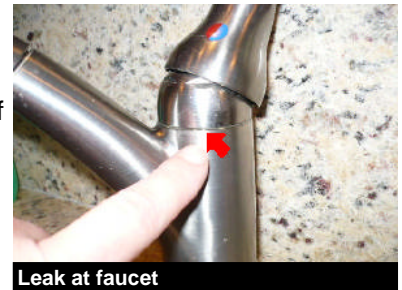
Stainless Steel. Leak noted at base of faucet handle- see photo for location. A licensed plumber should be called to make further evaluation and repairs as needed. Evidence of past leak at fittings. No leak detected at time of inspection.

Leak at faucet

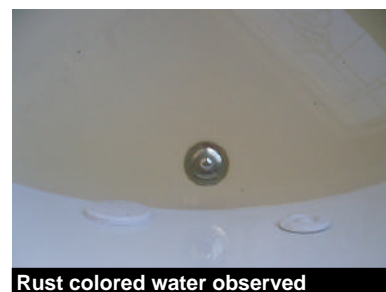
Shower and whirl pool: Functioning as intended. Note: rust colored water and rust flakes observed in master tub. Recommend investigating further and inquiring with licensed plumbing if any corrective measures are needed. Note: unable to access motor area of whirl pool tub. Access area is caulked and painted to wall- damage is possible if removed.

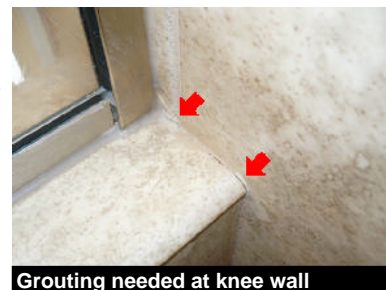
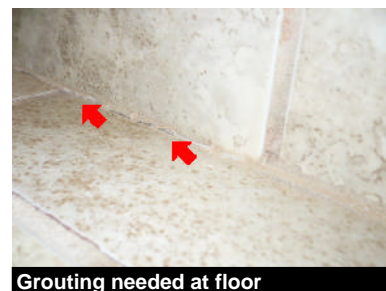
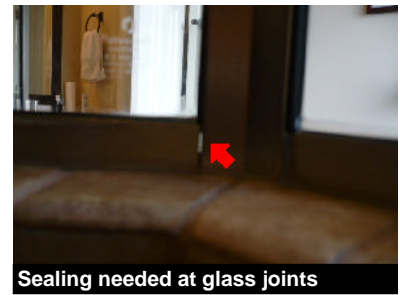
Caulking and/or re-grouting is needed to prevent water intrusion at tile against top of tub and at shower knee wall area adjacent to glass and shower area adjacent to floor and walls. Caulking needed at glass enclosure at joint areas (see photo's)
