November 19, 2008

Re: Heritage Neighborhood  
Wake Forest, NC 27587

#### **REPORT SUMMARY**

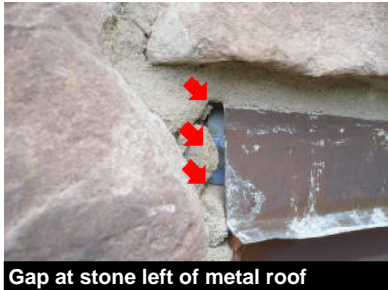
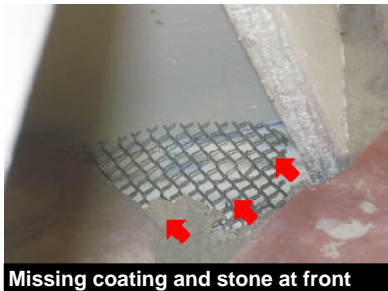
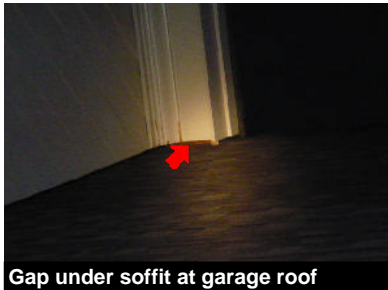
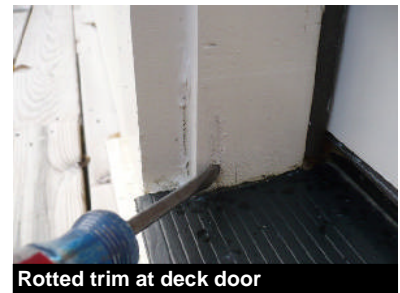
Front Elevation: Gap/ void under soffit adjacent to garage roof- potential for wind driven rain entry. Recommend flashing area as needed. Re-painting needed at non treated rake board trim adjacent to garage roof to prevent rotting. Gaps/ void at stone left of metal roof at garage bay window- seal area as needed to prevent water entry. Right side of bay window at garage: metal lathe and wall building paper exposed. Area is missing cementitious coating and stone. Add coating and stone to area as intended and to protect from wind driven rain entry.

Right Elevation: Loosing trim at rear of covered porch by downspout. Recommend securing and caulking areas as needed to prevent water entry.

Back Elevation: Rotted trim at left bottom of deck door. Repair areas as needed.

The exterior surfaces were observed while walking around the exterior of the home. The siding was found to be in adequate condition except as noted below: Front Elevation: Gap/void under soffit adjacent to garage roof-potential for wind driven rain entry. Recommend flashing area as needed. Re-painting needed at non treated rake board trim adjacent to garage roof to prevent rotting. Gaps/ void at stone left of metal roof at garage bay window- seal area as needed to prevent water entry. Right side of bay window at garage: metal lathe and wall building paper exposed. Area is missing cementitious coating and stone. Add coating and stone to area as intended and to protect from wind driven rain entry. Right Elevation: Loosing trim at rear of covered porch by downspout. Recommend securing and caulking areas as needed to prevent water entry. Back Elevation: Rotted trim at left bottom of deck door. Repair areas as needed. This list is only to be meant as a general guideline to help pinpoint areas repair. It is not meant to be every area of damage. A qualified repair contractor should survey the entire structure and repair/replace as needed.

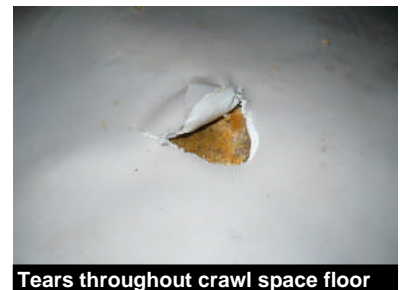
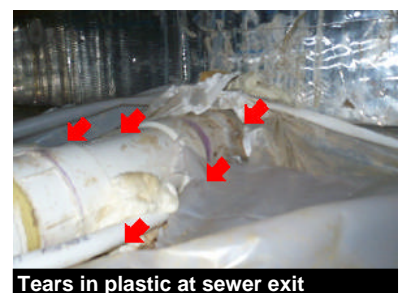
2. Numerous tears in plastic covering the floor, tears in plastic by sewer exit, loose taping at seams noted at floor. Standard building practices when installing a conditioned crawl space is for the floor to be completely sealed and taped at the seams. Recommend consulting with licensed general contractor regarding condition of plastic and seams and what corrective measures are needed.

Missing insulation around band joist at front right corner of crawl space and front left elevation side of crawl space. Add insulation as needed and intended.

Missing cover on electrical junction box- add cover for safety.

Numerous tears in plastic covering the floor, tears in plastic by sewer exit, loose taping at seams noted at floor. Standard building practices when installing a conditioned crawl space is for the floor to be completely sealed and taped at the seams. Recommend consulting with licensed general contractor regarding condition of plastic and seams and what corrective measures are needed. Missing insulation around band joist at front right corner of crawl space and front left elevation side of crawl space. Add insulation as needed and intended. Missing cover on electrical junction box- add cover for safety. Leak at plumbing supply fitting under master bathroom sink area. See photo. Recommend consulting with licensed plumber regarding leak and corrective measures.

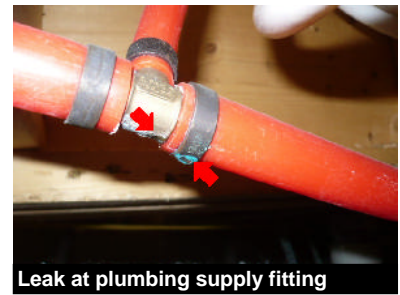
Leak at plumbing supply fitting under master bathroom sink area. See photo. Recommend consulting with licensed plumber regarding leak and corrective measures.

Leak at plumbing supply fitting

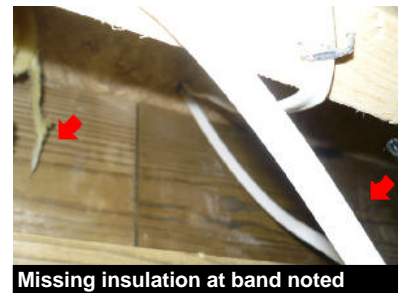
Missing insulation at band noted

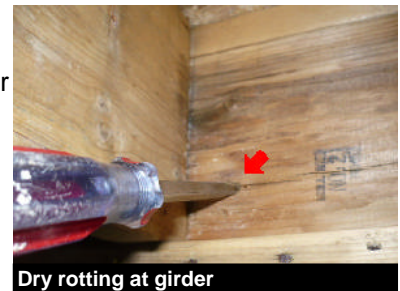
3. Girders: dry rotting observed at girder front right elevation near parallel plumbing pipes. When probed, screw driver was inserted into the outer joist. See photo. Recommend consulting with licensed general contractor regarding cause and condition of girder and repair as needed.

Wood, dry rotting observed at girder front right elevation near parallel plumbing pipes. When probed, screw driver was inserted into the outer joist. See photo. Recommend consulting with licensed general contractor regarding cause and condition of girder and repair as needed. All other beams: Functioning as intended.

Dry rotting at girder

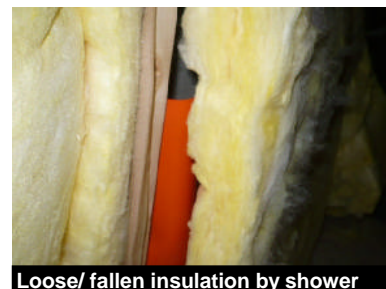
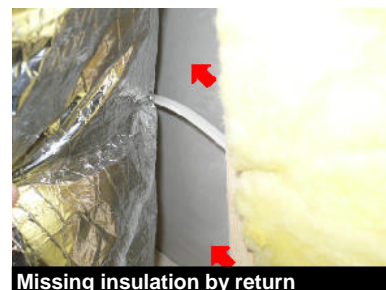
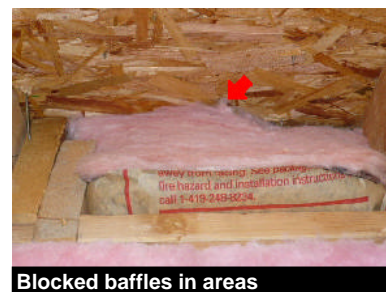
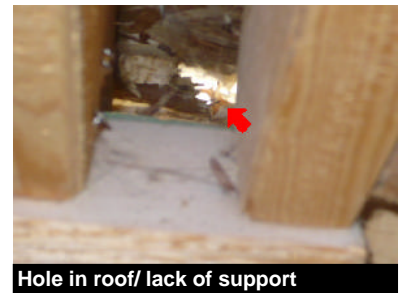
Walk in access right elevation by bonus: loose/ missing insulation noted at walls behind shower and above air return- secure insulation as needed. Blocked or missing baffles noted at batt insulation at rafters- see photo. Add or unblock baffles as needed.

Attic access left elevation at bonus area: Blocked/ or missing baffles noted. Add or unblock baffles as needed. Damaged roof decking noted at valley. Hole observed. Roof decking is not supported at end. Recommend repairing roof decking and adding support for attachment.

Conventional framing, Accessible at scuttle entrance at front bedroom. Accessible at walk in left and right elevations at bonus area. Accessible at walk in at rear closet in bonus. Accessible at rear left elevation in hall way. Viewing was limited, to walk boards, Personal items blocked some view. The attic was inspected using a standard flashlight. Viewing was limited or restricted by framing members, duct work, insulation, and plumbing or mechanical systems. Scuttle access front bedroom: door does not latch. Secure as needed to prevent loss of conditioned air. Walk in access right elevation by bonus: loose/ missing insulation noted at walls behind shower and above air return- secure insulation as needed. Blocked or missing baffles noted at batt insulation at rafters- see photo. Add or unblock baffles as needed. Attic access left elevation at bonus area: Blocked/ or missing baffles noted. Add or unblock baffles as needed. Damaged roof decking noted at valley. Hole observed. Roof decking is not supported at end. Recommend repairing roof decking and adding support for attachment. All other attic access areas: Functioning as intended.

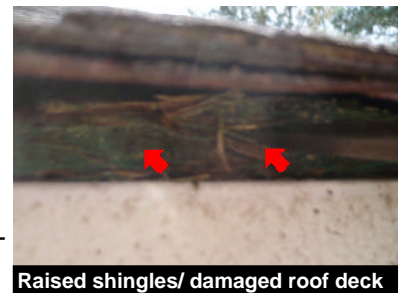
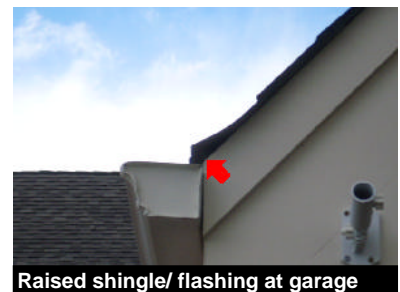
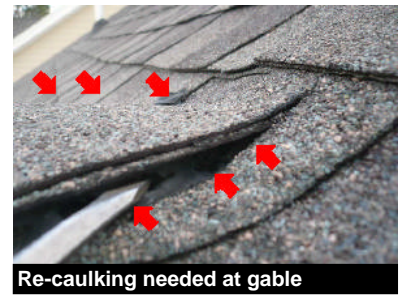
5. Raised shingles and exposed roof decking left side of front porch. Delaminated roof decking observed. Evidence of exposure to wind driven rain. Repair roof decking and shingles to prevent

water entry. Raised flashing behind gutter and raised shingle front left corner of garage roof- see photo for location. Secure flashing and shingle to prevent water entry. Re-caulking needed at cut and fold area of shingles at rear gable against main part of house- see photo. Potential for water entry. A licensed roofing contractor should be called to make further evaluation and repairs as needed.

Raised shingles and exposed roof decking left side of front porch. Delaminated roof decking observed. Evidence of exposure to wind driven rain. Repair roof decking and shingles to prevent water entry. Raised flashing behind gutter and raised shingle front left corner of garage roof- see photo for location. Secure flashing and shingle to prevent water entry. Re-caulking needed at cut and fold area of shingles at rear gable against main part of house- see photo. Potential for water entry. A licensed roofing contractor should be called to make further evaluation and repairs as needed.

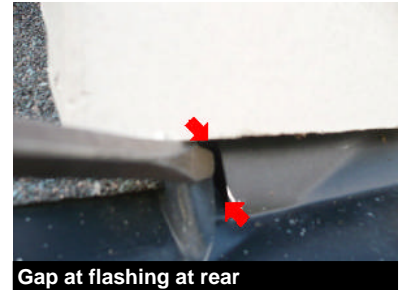
6. The potential for water entry is present. Gap at flashing at rear of roof right of covered porch above family room area ( see photo). A licensed roofing contractor should be called to make further evaluation and repairs as needed.

Metal, The potential for water entry is present. Gap at flashing at rear of roof right of covered porch above family room area ( see photo). A licensed roofing contractor should be called to make further evaluation and repairs as needed.

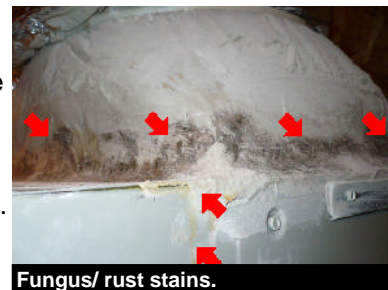
8. Attic: Left elevation side. Clean out noted at trap. Cover missing at clean out. A clean out located before the trap can disrupt the negative pressure necessary for proper flow of condensate. Recommend adding cover as needed. Note: inspector placed insulation in clean out for temporary fix at time of inspection.

Mold/ fungus noted around plenum at top of unit. Evidence suggest air leak and condensation forming around top of unit. Have licensed HVAC mechanical contractor evaluate the entire heating system and repair as needed.

**SECONDARY UNIT:** Attic: Left elevation side. Clean out noted at trap. Cover missing at clean out. A clean out located before the trap can disrupt the negative pressure necessary for proper flow of condensate. Recommend adding cover as needed. Note: inspector places insulation in clean out for temporary fix at time of inspection. Mold/ fungus noted around plenum at top of unit. Evidence suggest air leak and condensation forming around top of unit. Have licensed HVAC mechanical contractor evaluate the entire heating system and repair as needed.

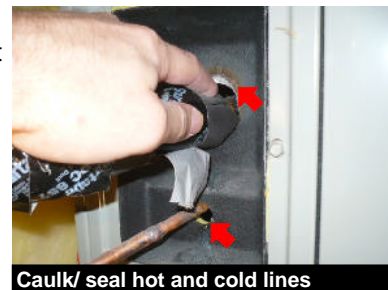
9. Attic: Right elevation side. Caulking needed around hot and cold suction lines at side of unit to prevent loss of conditioned air. Recommend consulting with licensed HVAC mechanical contractor for corrective measures.

Attic: Right elevation side. Caulking needed around hot and cold suction lines at side of unit to prevent loss of conditioned air. Recommend consulting with licensed HVAC mechanical contractor for corrective measures.

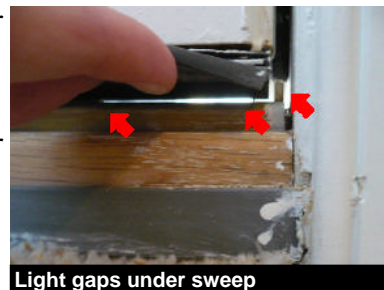
11. Rear covered deck door: does not latch. Repair as needed. Master deck door and door to garage: light gaps under door at threshold. Sweep does not make full contact with threshold. Loss of conditioned air noted. Repair areas as needed.

Rear covered deck door: does not latch. Repair as needed. Master deck door and door to garage: light gaps under door at threshold. Sweep does not make full contact with threshold. Loss of conditioned air noted. Repair areas as needed.

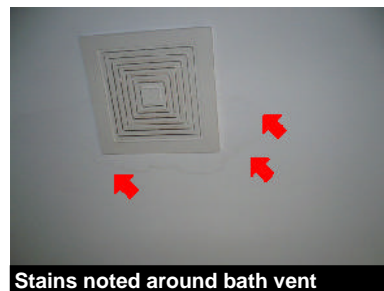
13. Stains noted in master bedroom by bath vent fan. Unable to determine if active leakage exists. Make inquiry with the seller as to the history of leaks. Recommend investigating areas further and repair as needed.

Drywall, Stains noted in master bedroom by bath vent fan. Unable to determine if active leakage exists. Make inquiry with the seller as to the history of leaks. Recommend investigating areas further and repair as needed.

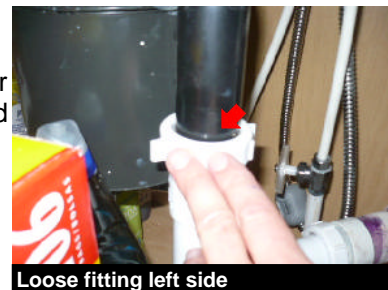
15. Loose fittings under left and right sides of sink. Loose fittings can cause leaks to occur. See photo's. A licensed plumber should be called to make further evaluation and repairs as needed.

Stainless Steel. Loose fittings under left and right sides of sink. Loose fittings can cause leaks to occur. See photo's. A licensed plumber should be called to make further evaluation and repairs as needed.

Loose fitting left side

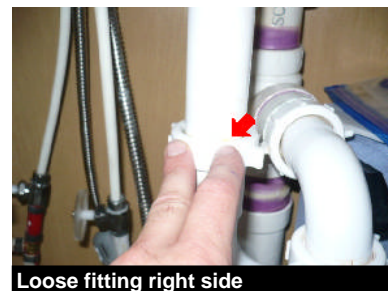
Loose fitting right side

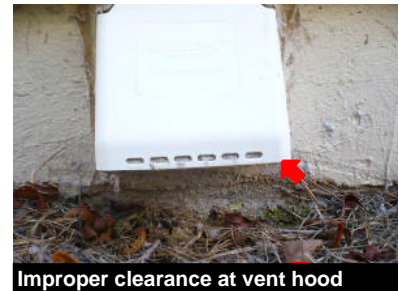
16. Improper clearance noted at vent hood at exterior. Standard building practices are to have a minimum of 12" clearance from grade under a laundry vent hood for fire safety. Further evaluation and repairs will be needed by a licensed HVAC mechanical contractor. Laundry sink is provided, Functioning as intended.

Improper clearance noted at vent hood at exterior. Standard building practices are to have a minimum of 12" clearance from grade under a laundry vent hood for fire safety. Further evaluation and repairs will be needed by a licensed HVAC mechanical contractor. Laundry sink is provided, Functioning as intended.

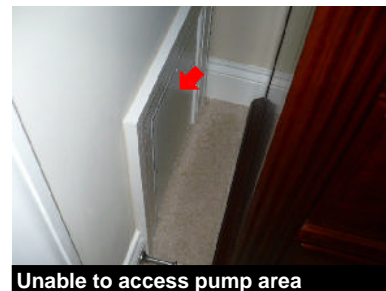
Functioning as intended. Note: unable to access pump area under tub due to personal items blocking access.

Unable to access pump area

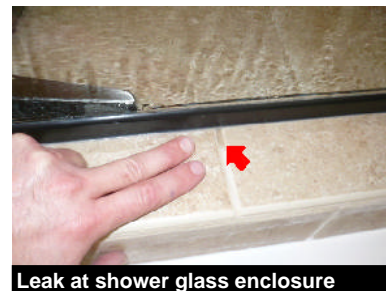
17. Leaks noted around shower glass enclosure at back of seat area. See photo. Repair as needed to prevent water from exiting the shower.

Leaks noted around shower glass enclosure at back of seat area. See photo. Repair as needed to prevent water from exiting the shower.

Leak at shower glass enclosure

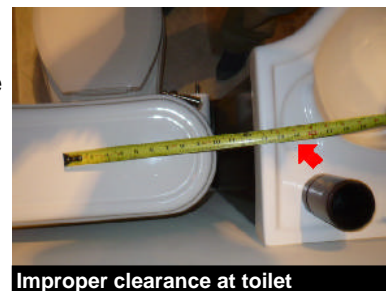
Functioning as intended. Note: improper clearance observed at toilet. Standard building practices are to have a minimum 15" clearance from the middle of the toilet tank to each side. Have a licensed plumber make proper repairs as needed.

Improper clearance at toilet

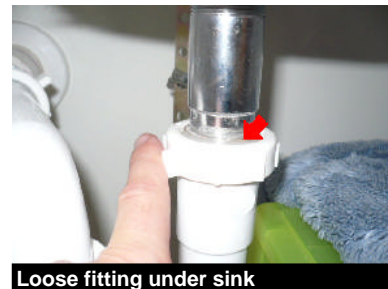
18. Loose fittings noted under right sink. Loose fittings can cause leaks to occur. A licensed plumber should be called to make further evaluation and repairs as needed.

Loose fittings noted under right sink. Loose fittings can cause leaks to occur. A licensed plumber should be called to make further evaluation and repairs as needed.
