October 28, 2010

Raleigh, NC 27617

#### **REPORT SUMMARY**

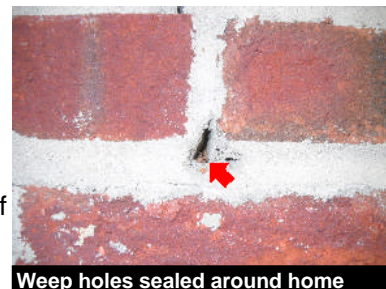
The exterior surfaces were observed while walking around the exterior of the home. The siding was found to be in adequate condition except as noted below: Around Home: Weep holes at the brick veneer wall do not extend fully to back side of wall cavity. The cavity behind the brick is ventilated by the induction of air up and through the weep hole. Proper ventilation is an important element in moisture control between the brick and wall frame.

Recommend consulting with brick mason regarding weep holes and what corrective measures are needed. Caulking needed around windows adjacent to brick to prevent water entry, gaps observed. Front Elevation: Caulking needed between the metal threshold at the front door and the brick ledge under the door to prevent water entry. Moisture darkened fascia board observed behind and above gutter above the master bedroom window. Area viewed from master bedroom window with inspection mirror on pole. See photo. Probe areas for moisture damage and repair as needed. Patched cracks in brick veneer observed above the master bedroom window and to right of the front porch along the brick wall. Right Elevation: Crack in brick veneer below the master bedroom window. Crack travels to the top of the dining bay window. Horizontal crack in brick veneer to by the master toilet window. The cracks are an indication of movement in the brick veneer. The movement can progress and change over the life of the home. A licensed general contractor should be consulted to evaluate the home and determine the cause of the crack and if what corrective measures are needed. Caulking needed at the wood trim at top of the bay window adjacent to brick in areas to prevent water entry. Rotted wood trim at the top of the dining bay window. Rotted area is above the large fixed window. Repair/ replace wood as needed. Weep hole to right of hose faucet has been sealed- repair weep hole as needed to function as intended. Patched cracks in brick veneer noted above master bedroom window. Back Elevation: Caulking needed at the vertical trim board adjacent to brick at the left corner area above the second floor cantilever. Evidence of wood destroying insects observed at the fascia board left side of sunroom. Bored hole observed. Consult with pest specialist regarding evidence of pest and what corrective measures are needed. Rotted wood trim and window sills at the sunroom windows. Aprox. 3 windows along the back side of the sunroom have rotted wood and or sills. Evidence of previous patch or repair noted in area. Evidence indicates improper repairs were made. Not all of the rotted wood was removed and the wood filler or patch was not able to cure as intended. Rotted wood is still present. All rotted wood should be completely removed. Consult with specialist regarding damaged areas and repair as needed. Caulking needed around the deck light adjacent to wall to prevent water entry. Caulking needed at the metal threshold adjacent to wood trim at the exterior door per manufacture installation guidelines. Rotted wood trim in several areas around the oval window at the rear stair landing.

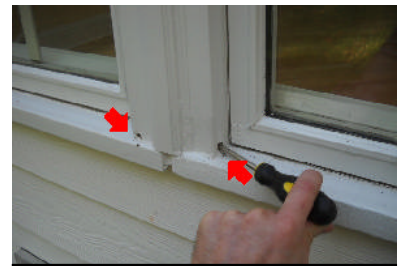
Several rotted areas/sunroom wind.

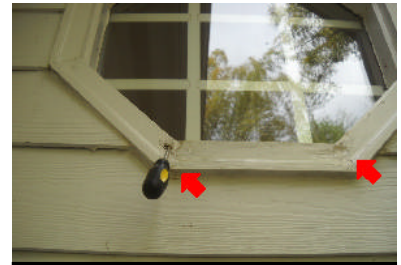
Rotted areas oval window at rear

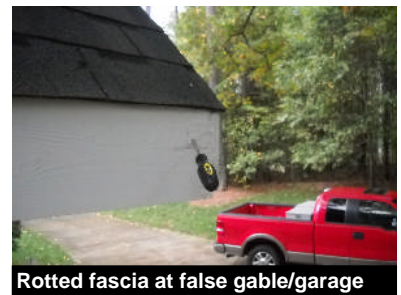
Rotted fascia at false gable/garage

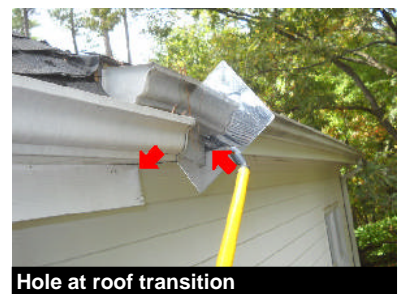
Hole at roof transition

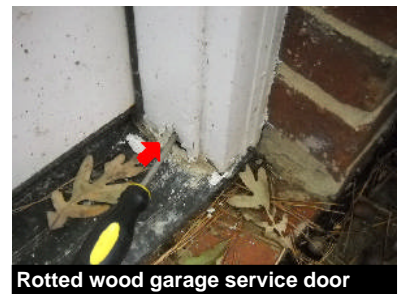
Left Elevation: Rotted wood around the garage service door. Evidence of improper patch or repair. Rotted wood is still present. All rotted wood should be removed for proper repairs. Caulking needed around garage carriage lights adjacent to wall to prevent water entry. Gaps noted. Missing weep hole at garage right wing wall. Add weep hole as intended.

Rotted wood garage service door

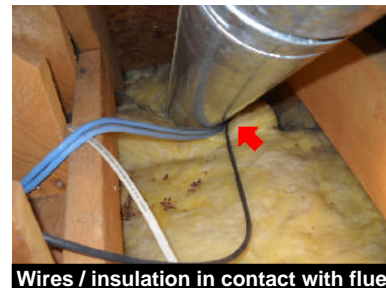
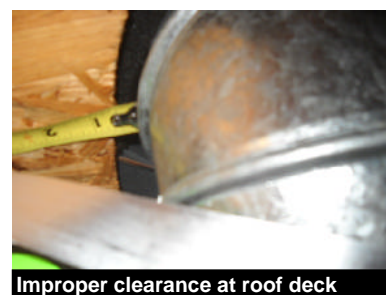
Improper clearance to combustibles observed at flue pipe in attic. Manufacture label on vent pipe indicates a minimum 1" clearance from combustibles and building materials. There is insulation in contact with the flue, there are electrical wires in contact with flue, the roof decking is closer than 1" at the roof, The shingles are touching the flue. Clear combustibles away from vent pipe as needed for fire safety. Consult with contractor for corrective measures.

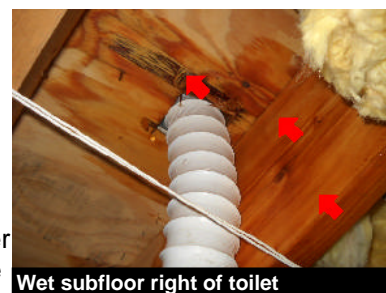
Remove wood debris and trash from the crawl space area, Fallen insulation and or missing insulation noted throughout, Recommend consulting with insulation specialist regarding fallen/missing insulation and what corrective measures are needed. Wet/ saturated subfloor under the powder bathroom. Area is to right of the toilet and by the bath vent duct. See powder room below in report for evidence of leak in the wall. Moisture damaged, rotted subfloor observed by the rear deck door. Evidence indicates water entry has occurred. Recommend consulting with licensed contractor regarding evidence of leaking and damaged subfloor and what corrective measures are needed. Joist:Hangers are not fully nailed off per manufacture guidelines. Standard building practices and per manufacture guidelines are to fully nail off hangers and provide equal number of nails in hangers for even weight distribution. Recommend consulting with licensed general contractor regarding hangers and what corrective measures are needed.

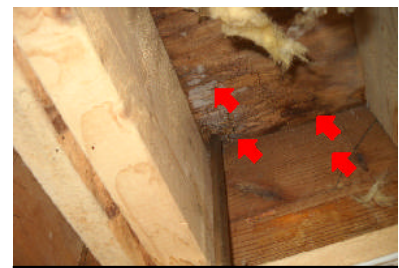
Moisture damaged, rotted subfloor observed by the rear deck door. Evidence indicates water entry has occurred. Recommend consulting with licensed contractor regarding evidence of leaking and damaged subfloor and what corrective measures are needed.

Damaged subfloor by rear deck door

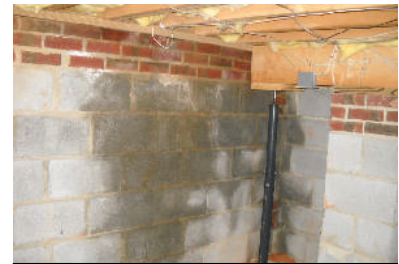
Staining was observed: Evidence of present water penetration is noted- Seen at front porch and foundation wall to right of front porch. Evidence indicates poor grade and or water entry at the front porch between the home and porch. Recommend consulting with grading specialist and/or water proofing specialist regarding water entry and what corrective measures are needed.

Wet walls at front by porch

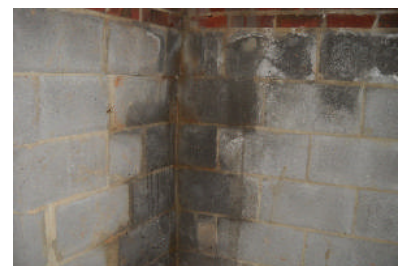
Wet walls corner right of porch

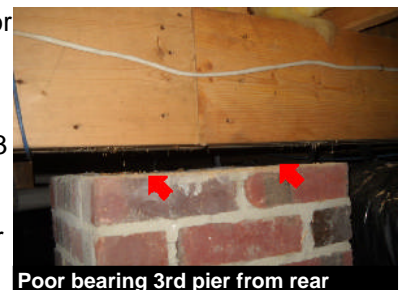
Girders: Wood, Poor end bearing is found: Poor bearing at girders in crawl space. Wood blocking was slid out from under girders. Evidence indicates full weight of girder is not bearing on pier. See photo. Area is aprox. the 3 pier from the rear elevation wall from the sunroom- area is near kitchen. Poor end bearing at the 4th pier from rear sunroom- near kitchen. Not all of girder is bearing on wood blocking. All sections of girder should be fully bearing in order to evenly distribute weight to pier and footing. Poor bearing at the same girder at the front of the foundation wall. A pilaster is missing against the side of the foundation for the girder to bear. The girder is suspended without bearing. Attempted repair was made using a screw jack to provide support. The screw jack was improperly installed and was easily moved. Evidence indicates full weight bearing was not achieved. Evidence indicates a structural deficiency in the floor/ foundation system. A professional structural engineer should be consulted regarding the missing pier and provide corrective measures. A North Carolina licensed general contractor should perform the work necessary for repairs according to the engineers specifications.

Poor bearing 3rd pier from rear

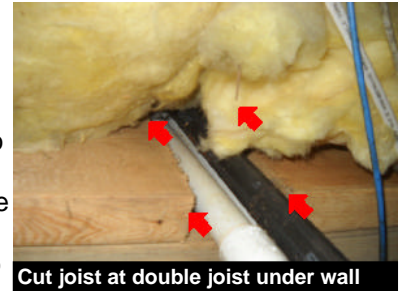
Floor Joist, Wood: Area near rear elevation by the suction line and condensate lines where they pass through the subfloor: Cut joist at double floor joist observed. Standard building practices are to double floor joist under walls to support weight of wall. Floor joist are intended to be doubled and continuous directly under the load point of wall. Lack of support observed under floor and improper or no repairs made to cut floor joist. Recommend consulting with licensed general contractor regarding regarding cut floor joist and what corrective measures are needed. Cut floor joist observed by the powder bathroom. Repairs have been made to cut floor joist. Repairs made are not a typical field repair to cut joist around plumbing pipes. Standard practices are to frame a header and attached all sections of joist together with joist hangers. Consult with licensed contractor regarding repairs made and repair areas as needed.

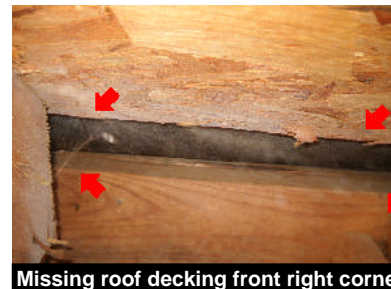
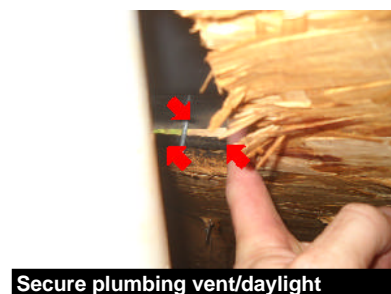
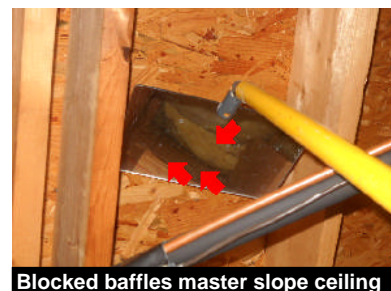
Conventional framing, Accessible, Walk up attic, Viewing was limited, to walk boards, The attic was inspected using a standard flashlight. Viewing was limited or restricted by framing members, duct work, insulation, and plumbing or mechanical systems. Missing roof decking and lack of support at the front right corner of the home. Aprox. 5-6" of shingle tabs area exposed from the attic and lack of support is provided under the singles. Without proper support or nailing, the shingles can move allowing wind driven rain entry. See photo. Add roof decking as needed and intended in area to provide proper support. Hanger at header above the bonus dormer: Hangers are not fully nailed off per manufacture guidelines. Standard building practices and per manufacture guidelines are to fully nail off hangers and provide equal number of nails in hangers for even weight distribution. Recommend consulting with licensed general contractor regarding hangers and what corrective measures are needed. Daylight observed at the 4" plumbing boot behind the air handler. The roof decking was over cut and the center nail supporting boot flashing is not inserted into any wood. The exterior areas were observed. Potential for wind driven rain entry. Consult with licensed roof contractor regarding corrective measures. Attic ventilation: Rear elevation at the slope of the master bathroom roof line: Blocked baffles/missing baffles observed throughout the attic area. Blocked baffles can lead to restricted air flow and lack of attic ventilation. Recommend consulting with licensed contractor regarding baffles and what corrective measures are needed.

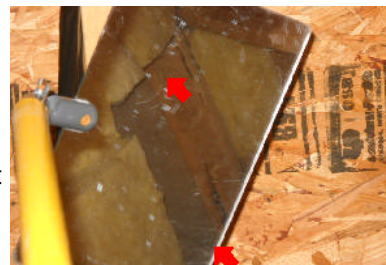
**Missing insulation top of master bath**

Insulation installed is R-13 in area. Insulation should be R-30. Missing insulation at the top of the master bathroom ceiling. Area was viewed with inspection mirror on pole to inspect top of ceiling. Numerous areas of fallen/ missing insulation at the knee walls of the master bathroom. Repair insulation as needed. Exposed sheet rock over the bonus ceiling/laundry area. Exposed sheet rock/ missing insulation at the stair well ceiling of the bonus. See section of thermal imaging. Crawl, Fallen insulation noted, Recommend consulting with insulation specialist regarding fallen/missing insulation and what corrective measures are needed.

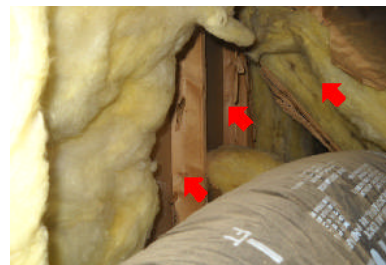
**Missing/fallen around master bath**

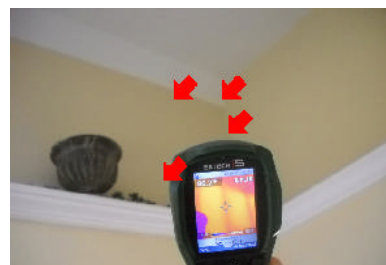
**Missing insulation master bath walls**

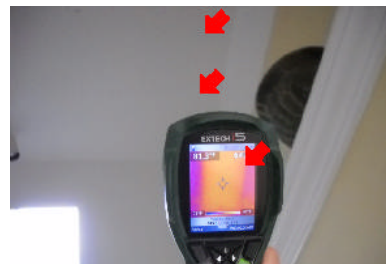
**Missing insulation master bath ceiling**

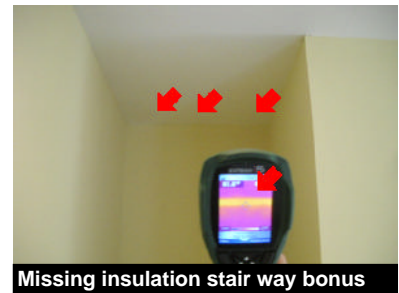
Missing insulation stair way bonus

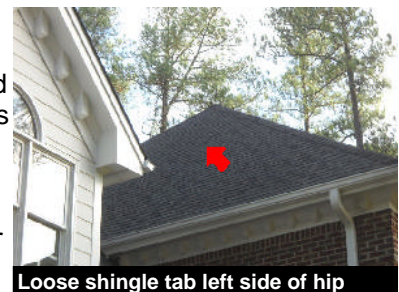
Loose shingle tab, shingle tab has slid down: Left side of hip roof. See photo for location. Secure shingle as needed. Hole/ void observed at shingles at end of water table where shingles meet rake board trim. See photo of area. Potential for water entry. Recommend sealing areas as needed to prevent water entry. Recommend consulting with licensed roofer for corrective measures. Torn shingles noted at the bay window at the dining room. Exposed roof decking observed at edge of bay roof at dining room. Area was viewed from master window with mirror on inspection pole. See photo. Repair areas as needed to prevent water entry at exposed roof decking. A licensed roofing contractor should be called to make further evaluation and repairs as needed.

Loose shingle tab left side of hip

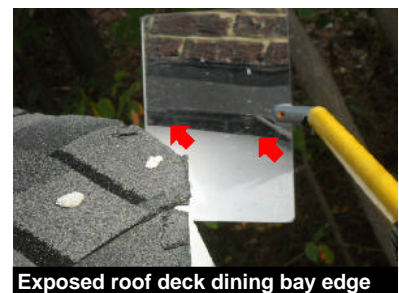
Exposed roof deck dining bay edge

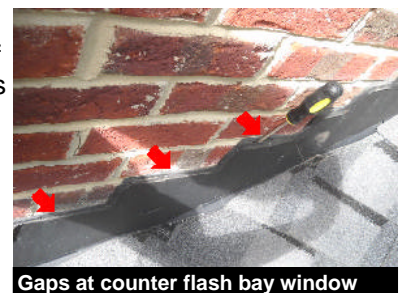
Metal, The potential for water entry is present: Raised flashing observed by dormer window of bonus right side. See photo. Secure flashing as needed to prevent wind driven rain entry. Gap at flashing above front door adjacent to wall at right side. Seal flashing as needed to prevent water entry. Right elevation: Gaps at head wall flashing/ counter flashing above the dining bay window. Numerous areas observed. Moisture stain observed in dining room under bay.

Gaps at counter flash bay window

Evidence indicates periodic moisture entry. Repair flashing as needed to prevent water entry. Raised flashing at the bay window above the dining room. See photo. Secure flashing as needed. Rear elevation: metal vent stacks: No

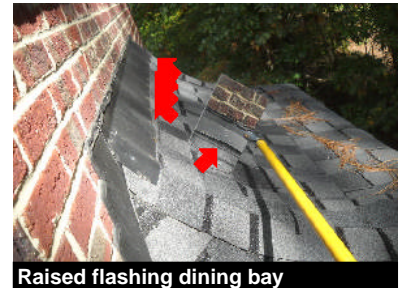
Raised flashing dining bay

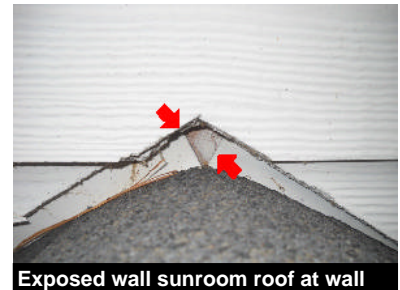
roof cement has been added or missing cement over nail heads at flashing. Nail heads can loosen, back out, cause flashing to raise, and conditions conducive to water entry. Standard building practices are to seal nail heads with roof cement to secure nails in place. Repair areas as needed. Rear sunroom: improperly installed flashing at the ridge of the sunroom adjacent to the side of the home. Flashing does not overlap as intended. Exposed wall sheathing observed. See photo. Flash area as needed to prevent water entry. A licensed roofing contractor should be called to make further evaluation and repairs as needed.

Exposed wall sunroom roof at wall

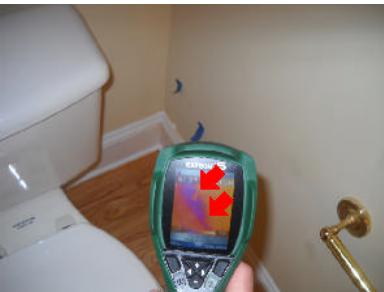
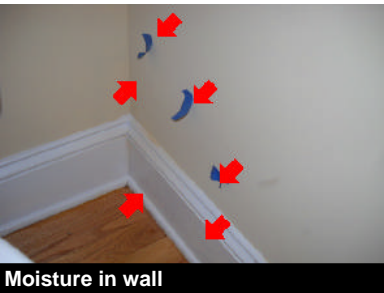
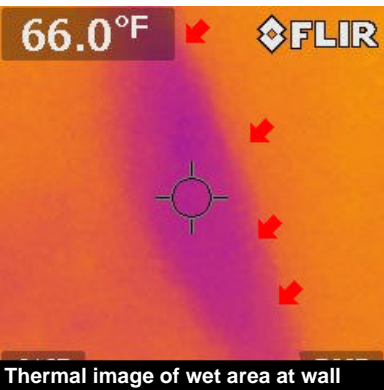
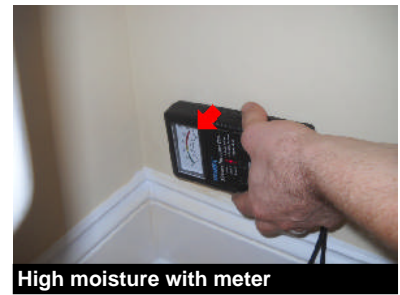
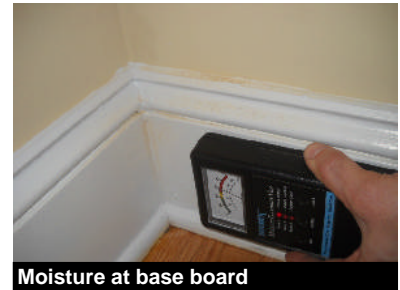
- MATERIAL:** Readily visible piping is, CPVC.
- CONDITION:** Evidence of plumbing leak at the wall in powder room to right of toilet. A infrared thermal imaging camera was used to scan walls. A large area was observed at the bottom right corner of the wall to right of the toilet. The image was consistent with moisture/ water. A moisture meter was then placed on the wall to confirm that high moisture is present inside the wall. See photo. Blue tape was positioned to outline the wet area. See thermal image. Wet subfloor was observed in the crawl space. Recommend licensed plumber repair leaking pipes and survey all pipes and fittings for further leakage.

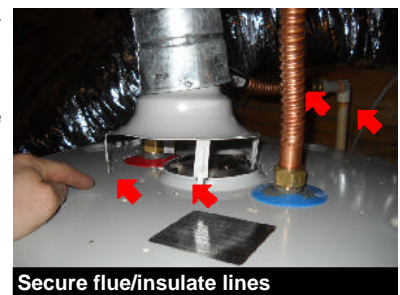
**TYPE:** Gas.  
**SIZE:** 50 Gallons.  
**LOCATION:** Attic.  
**CONDITION:** Recommend attaching (screwing) water heater flue break to top of water heater for safety to prevent the flue break from lifting off of water heater top. Missing foam insulation around the water lines and T&P valve. Fit pipe insulation over the incoming cold water line and the hot water line. Make sure that the insulation is against the top cover of the heater. Fit T & P valve insulation over valve. Make sure that the insulation does not interfere with the lever of the T & P valve. Secure all insulation using tape

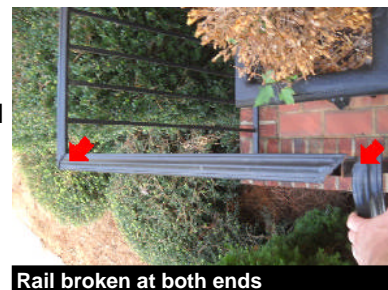
**TYPE:** Open design, Brick floor.  
**CONDITION:** Front porch rail loose- secure for safety. Sections of porch rail are broken and loose. See photo. Repair front porch rails as needed. Evidence of water entry between the porch and foundation wall. See above in crawl.

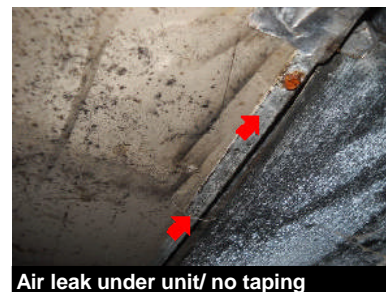
**PRIMARY UNIT:** Crawl: Comprehensive evaluation of the heat exchanger and combustion compartment are excluded from this inspection due to visibility and design limitations of the furnace. If you have concerns - recommend having licensed HVAC dealer conduct specialized testing in order to give comprehensive evaluation. Air leaks detected around plenum. Air leaks observed at the bottom of the unit. Recommend taping and sealing areas that are leaking to prevent conditioned air loss. No trap was installed at the auxiliary condensate line. Recommend adding trap as needed.

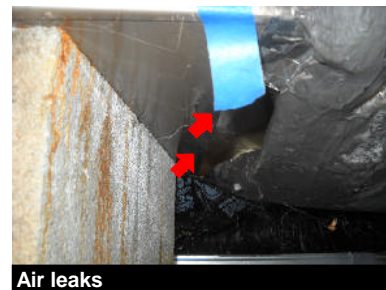
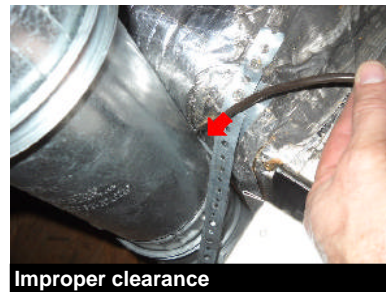
**SECONDARY UNIT:** Attic: Comprehensive evaluation of the heat exchanger and combustion compartment are excluded from this inspection due to visibility and design limitations of the furnace. If you have concerns - recommend having licensed HVAC dealer conduct specialized testing in order to give comprehensive evaluation. 1" Clearance from combustibles required around vent stack for fire safety. Electrical wire is touching the flue. Move wire as needed for safety. Air leaks detected around plenum. Recommend taping and sealing

areas that are leaking to prevent conditioned air loss. See photo. Have licensed HVAC mechanical contractor evaluate the heating system and give recommendations as to corrective measures.

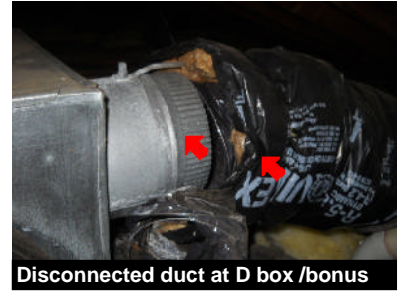
Ductwork is loose or disconnected, Air leaks at distribution box in attic over the bonus room. Attach and seal areas as needed to prevent loss of conditioned air. A licensed mechanical contractor should be called to make further analysis of the ductwork system.

Disconnected duct at D box /bonus

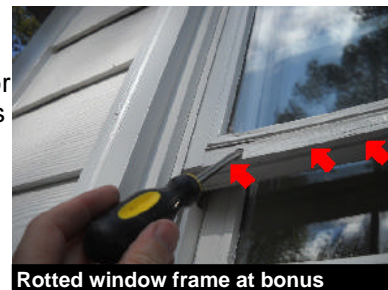
Rotted window frame at the top sash at the bonus dormer. See photo. Replace/ repair window as needed. Windows difficult to open or not open at all. Repair as needed to function as intended.

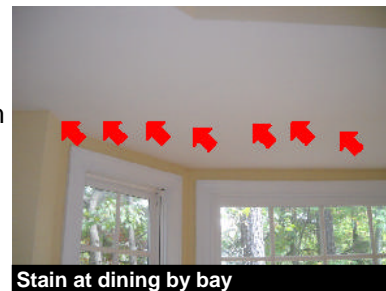
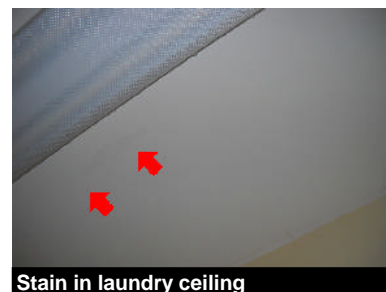
Drywall, Stains noted, Stain noted at ceiling in laundry room, investigate area further. Stain noted at ceiling at bay window in dining room. See photo. Evidence indicates water entry from the flashing or from above at the master bathroom. Investigate and repair areas as needed.

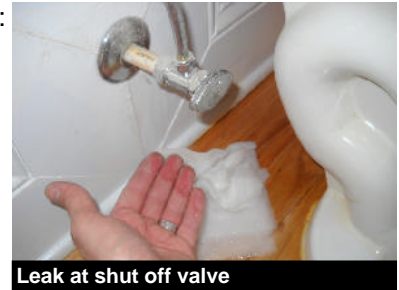
The following problems were noted at the toilet:  
Leak around shut off valve. Repair as needed.  
Have a licensed plumber make proper repairs  
as needed.
