January 9, 2009

Garner, NC 27529

REPORT SUMMARY

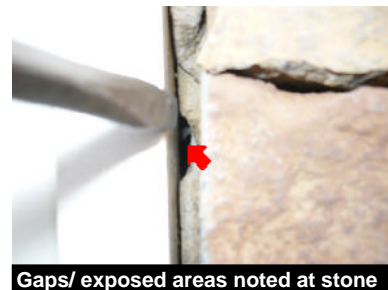
Areas exposed at vertical trim boards, above foundation vents, around window, and right of window at wall. Standard building practices for the application of stone are to cover the area behind the stone with a cementitious coating to prevent areas where wind driven rain entry could occur. Building paper, exposed lath, or wall sheathing should not be exposed. Recommend consulting with licensed general contractor regarding exposed areas and what corrective measures are needed. Recommend painting under side of trim at porch post to prevent water wicking up into trim which could cause rotting. Caulking/ sealing needed at siding adjacent to porch surface to prevent water entry (see photo).

Exposed wood and areas at stone
